Not Your Average Main Break By Mike Stanzel, Circuit Rider

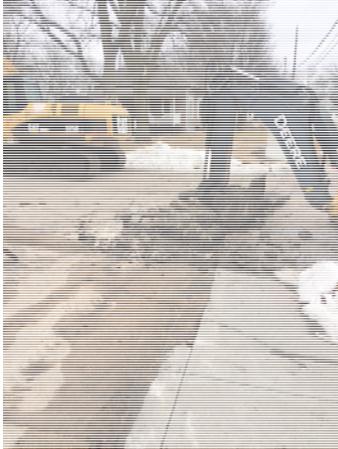
On a late Monday afternoon in January my phone rings and I see it's from an operator who I work with on a regular basis. I answer, "Hey, what's up buddy?" And his reply is, "I'm just standing here watching water gush from underneath the highway." I reply, "Be there first thing in the morning." Little did I know that I would be spending the next three days on what's otherwise known as the "water main break from hell."

I arrived on Tuesday morning. In the previous 24 hours his wells had pumped approximately 740,000 gallons more than normal putting the break at about 500 GPM. We then studied the map and began attempting to isolate the leak. This is where we started running into problem after problem.

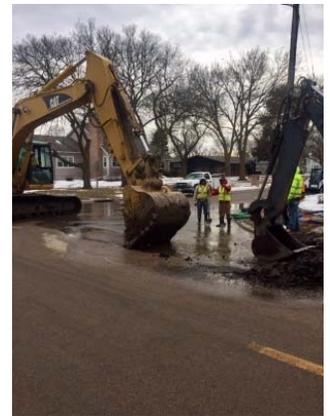
Concrete was removed and excavating was started all while full pressure was still on the main. Three gas-powered trash pumps were used to keep up with the flow until the main was exposed enough to put a repair sleeve on. Finally by 5 p.m. Thursday, the leak was repaired.

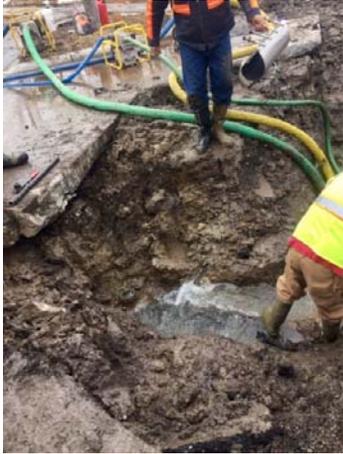
But that's not the end of it. Friday morning it broke again two feet from the previous break, and it also broke again on Monday across the road.

By the time it was said and done they had installed two new line stops and 55 feet of new pipe, had excavated clear across the highway and had replaced all the concrete. If I was to guess the total cost of this break, it's probably \$40,000 - \$50,000. This can definitely cause a financial burden to any size town.

How can this be prevented? It can't! All I can suggest is to keep good maintenance records. Keep track of where your breaks are occurring. If they are in the same area, prioritize them and try to get them scheduled for replacement. I can't stress enough that you have got to keep your town boards informed on the quality and condition of your water system.
